NATIONAL TRANSPORTATION SAFETY BOARD

AIRCRAFT ACCIDENT REPORT

WESTERN HELICOPTERS, INC.,
BELL UH-1B, N87701
VALENCIA, CALIFORNIA
JULY 23, 1982

NTSB/AAR-84/14
(SUPERSEDES - - NTSB/AAR-84/02)

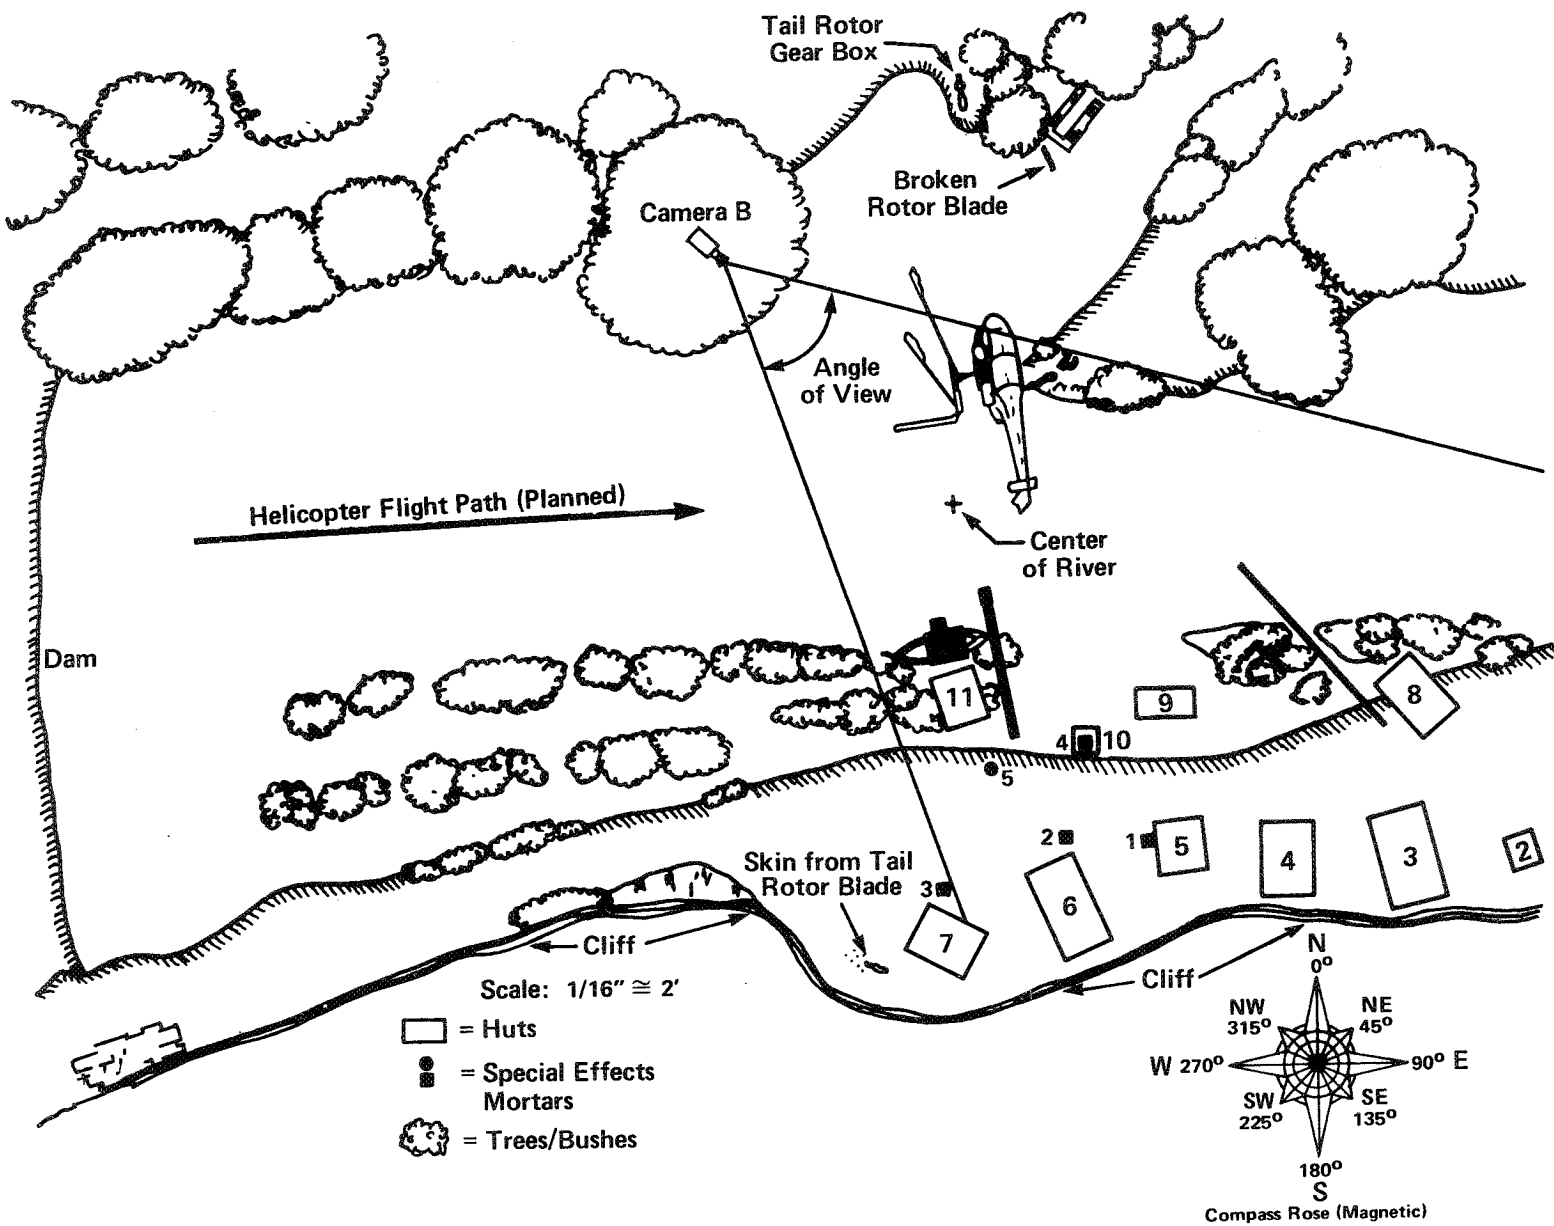
Figure 1.—Accident site.

The helicopter came to rest on its left side on a magnetic heading of 345°. The helicopter's structure, flight controls, and rotating assemblies, except the tail rotor assembly, remained intact. The main rotor mast assembly, including the main rotor blades and their associated components, were heavily damaged as a result of impact. Damage to the main rotor blades was consistent with the damage which would be expected if the blades were rotating at impact. The preimpact integrity of the main rotor flight control system was established; all of the damage to the main rotor flight control system was determined to be the result of impact. There was no evidence of any pre-existing malfunction or failure.

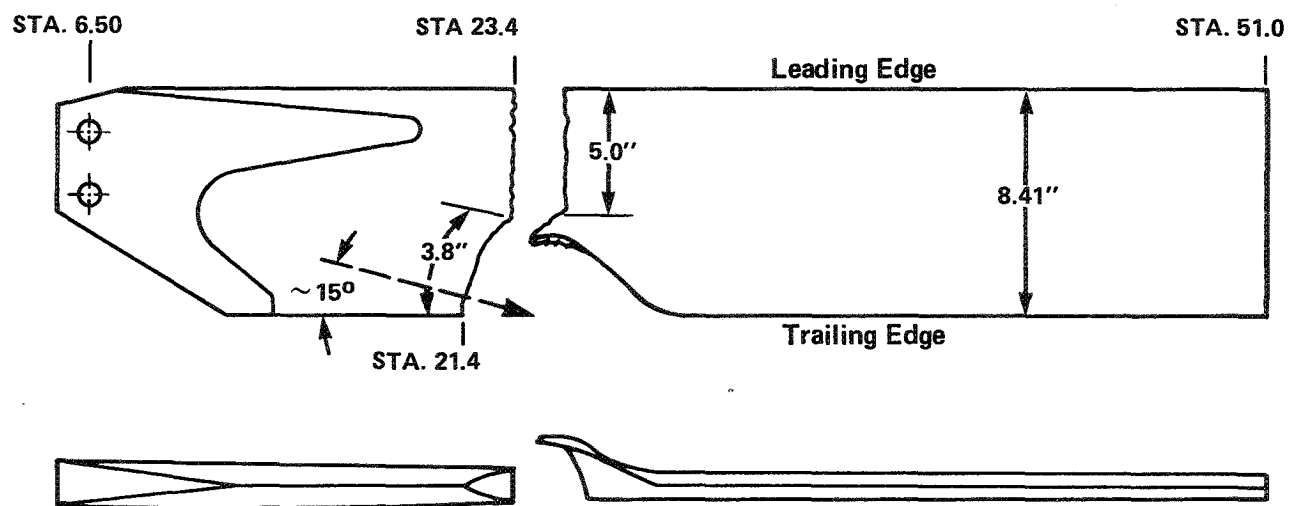
Figure 2.—Blade damage.

The tail rotor 90° gearbox, with one intact blade and the butt portion of the other blade attached to the hub assembly, was found about 41 feet north of the main wreckage. Tail rotor blade, serial No. A3-84197, had separated 18 1/4 inches outboard of its butt end. The outboard portion of the blade was found about 21 feet southwest of the tail rotor 90° gearbox. The broken tail rotor blade exhibited a semicircular indentation about 3 1/2 inches deep on its trailing edge; the indentation spanned the fracture line in the blade. (See figure 2.) The left side of the blade had two rectangular punctures just aft of its leading edge. Foreign particles were found on both fracture surfaces of the blade. Tail rotor blade serial No. A3-84164 remained attached to the hub assembly. About 33 1/4 inches of the blade skin was missing; the skin was found behind hut No. 7. (See figure 1.) Visual examination of the skin disclosed extensive curling at the butt end and extensive heat damage. Also, particles of a rubbery substance with wood embedded were found on the right side of the skin.

A foreign object impacted the tail rotor blade trailing edge approximately 18.25 to 22.3 inches (463.55 - 566.42 mm) from the butt end. The impact of the foreign object deformed the aft 4 inches of the tail rotor blade trailing edge at station 25. This deformation created an out-of-track condition of the tail rotor blade that may have resulted in the separation of the 90° gearbox and blades from the aircraft.

The separated portion of one tail rotor blade was found 21 feet away from the tail rotor gearbox to which the blade hub with the mating fracture surface was still attached. A matching semicircular indentation existed on the trailing edges of both portions of the fractured tail rotor blade. The matching indentations are conclusive evidence that the blade was struck by an object before the blade fractured, and that the fracture may have been precipitated by the damage inflicted by the object or by vibrational forces caused by the resulting imbalance in the tail rotor system.

The large piece of skin from the other tail rotor blade was found behind the No. 7 hut on the south side of the river. Tests showed that the skin had separated at the bonding surface (delamination) because of exposure to excessively high temperatures. Since the only source of high temperatures was the special effects explosions, the Safety Board concludes that the delamination resulted from the blade's exposure to the heat of the fifth special effects explosion which engulfed the tail rotor assembly. The delamination and high speed rotation of the blade would have caused the skin to flap as it separated from the blade structure. The consequent disruption of the blade's aerodynamic shape and the creation of a dynamic imbalance due to the loss of the skin could have resulted in forces sufficient to fracture the tail rotor gearbox flange and could have caused the tail rotor assembly to separate.

The Safety Board cannot identify with any degree of certainty the specific object which struck the tail rotor blade and caused the semicircular indentation at the point of fracture. The deformation of the fracture in the outboard portion of the blade

tends to indicate that the blade was struck from the right side and from the trailing edge. However, the Safety Board believes that any of the objects propelled upward by the special effects explosions would not have had sufficient mass and speed to inflict the evident damage if they had struck the blade from behind in its direction of rotation. It is more likely that an object traveling essentially perpendicular to the tail rotor blade's plane of rotation and striking the blade just forward of its trailing edge would have produced the necessary force to deform the blade. Under such conditions, the impulse force related to such an impact would have been very high because of the rotational speed of the blade. In these circumstances, the damage could have been inflicted by an object of relatively low mass. Furthermore, such an impact would have been consistent with the pressure differential across the blade (deflected to produce a left turn) and the movement of debris through the blade's rotational plane. The peculiar deformation of the fracture surface of the outboard portion of the blade could be explained by the twisting of the blade by the aerodynamic and dynamic forces which caused its fracture and by the impact of the blade against the drive shaft cover of the vertical pylon.
